Re: Dam Safety Inspection Report, Little Falls Dam, Field File No. 55.01

Underwater Inspection

**Little Falls Dam
Willow River State Park
St. Croix County, Wisconsin**

Tainter Gate Inspection

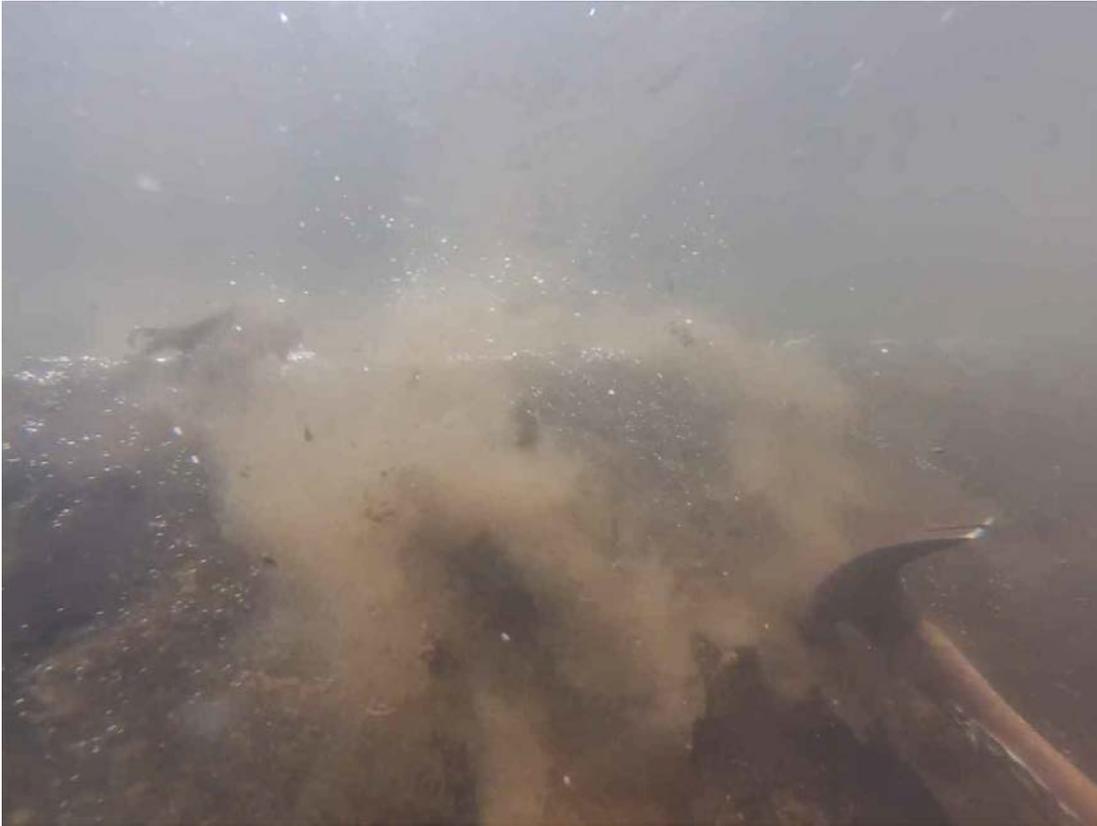
Photo 3: typical concrete condition underwater, algae at top of spillway at upstream side

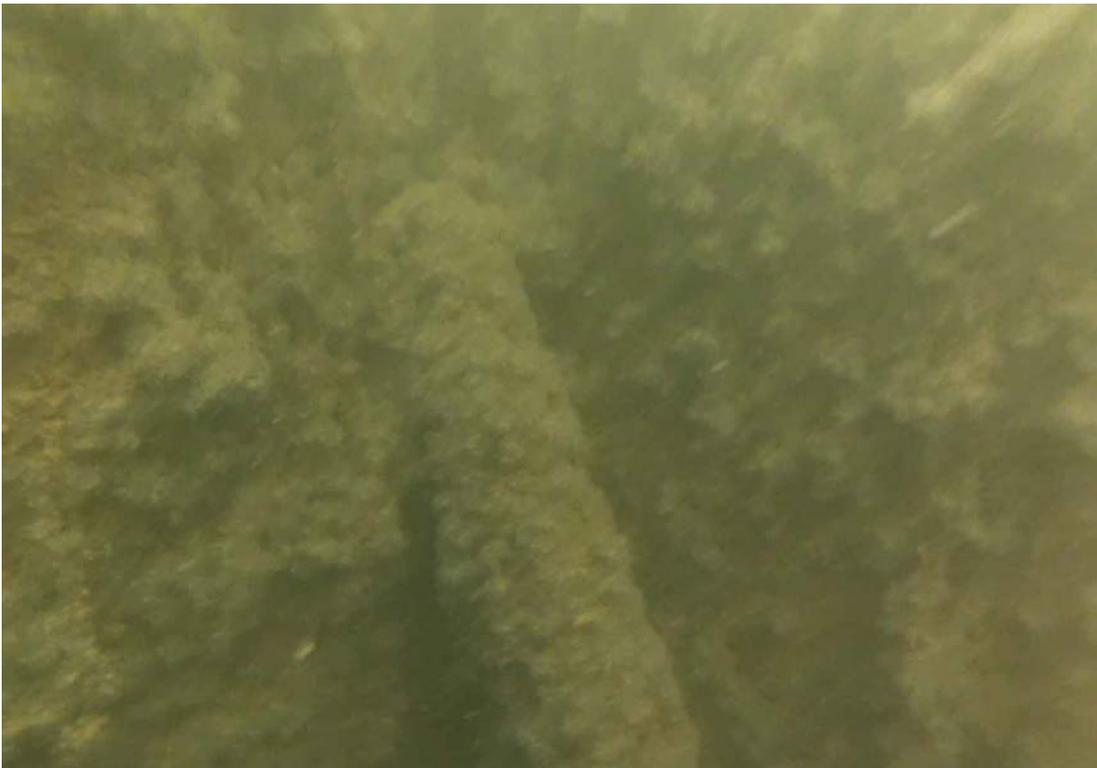
Photo 4: typical marine growth underwater and log in corner at south end of spillway, upstream side

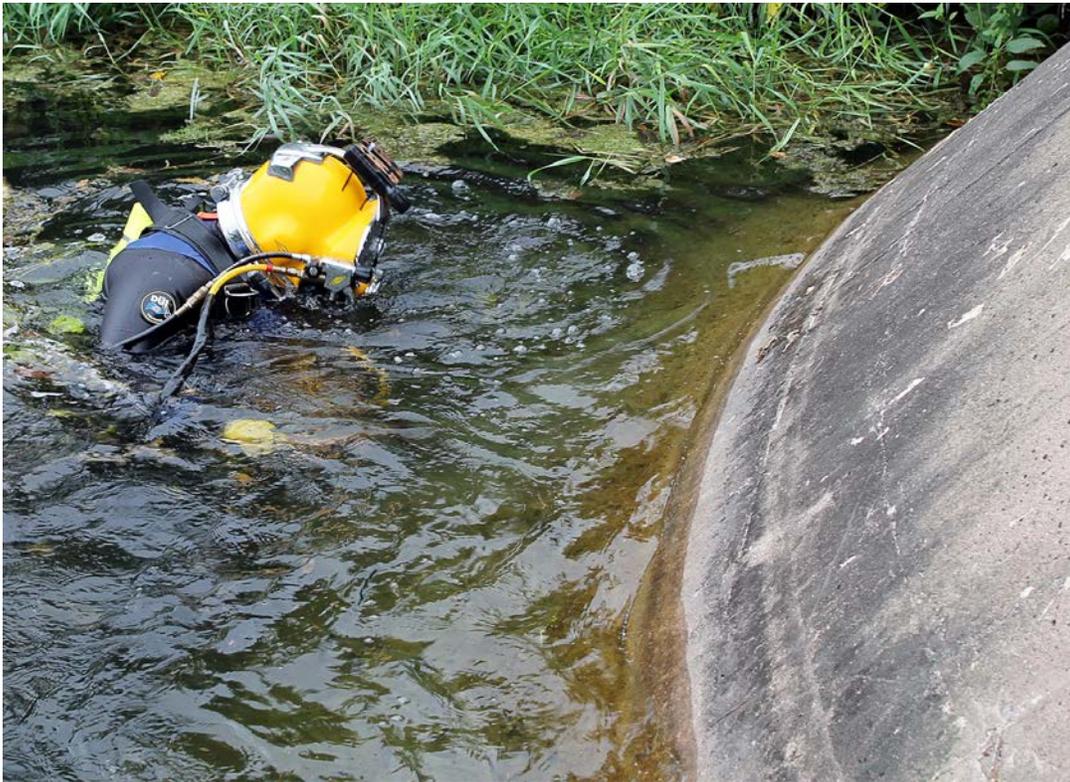
Photo 5: underwater inspection of non-overflow section

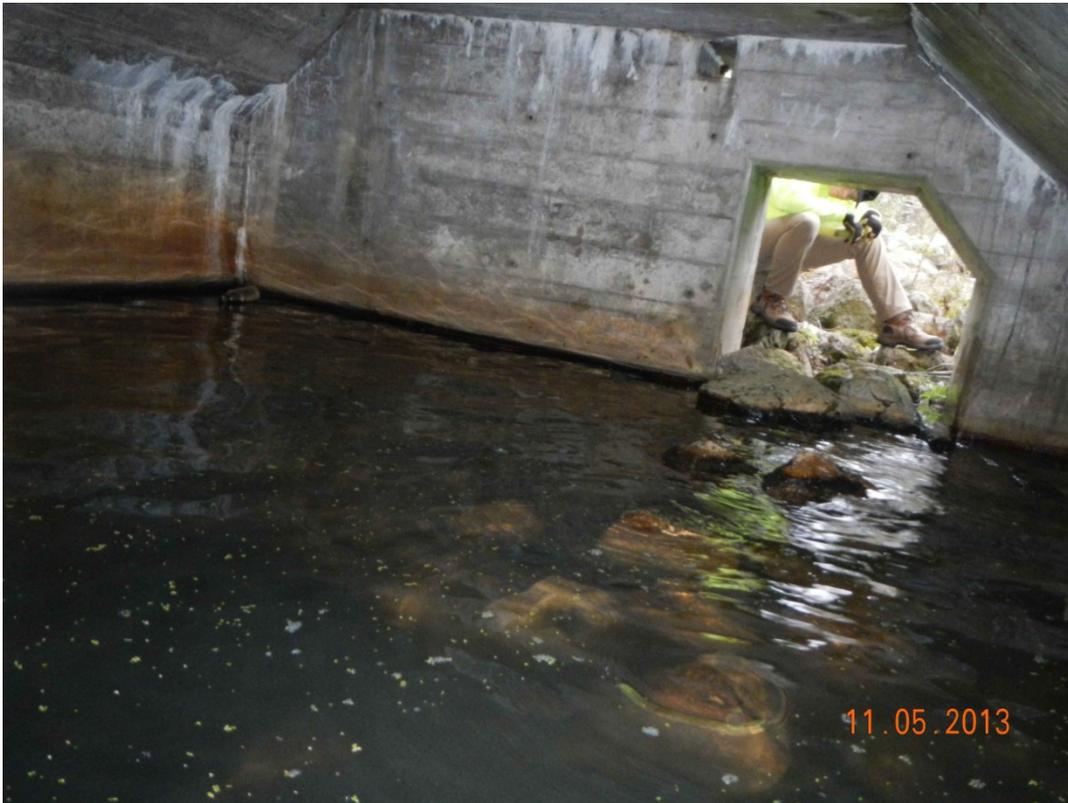
Photo 7: Bay 1 – south wall – opening to gallery

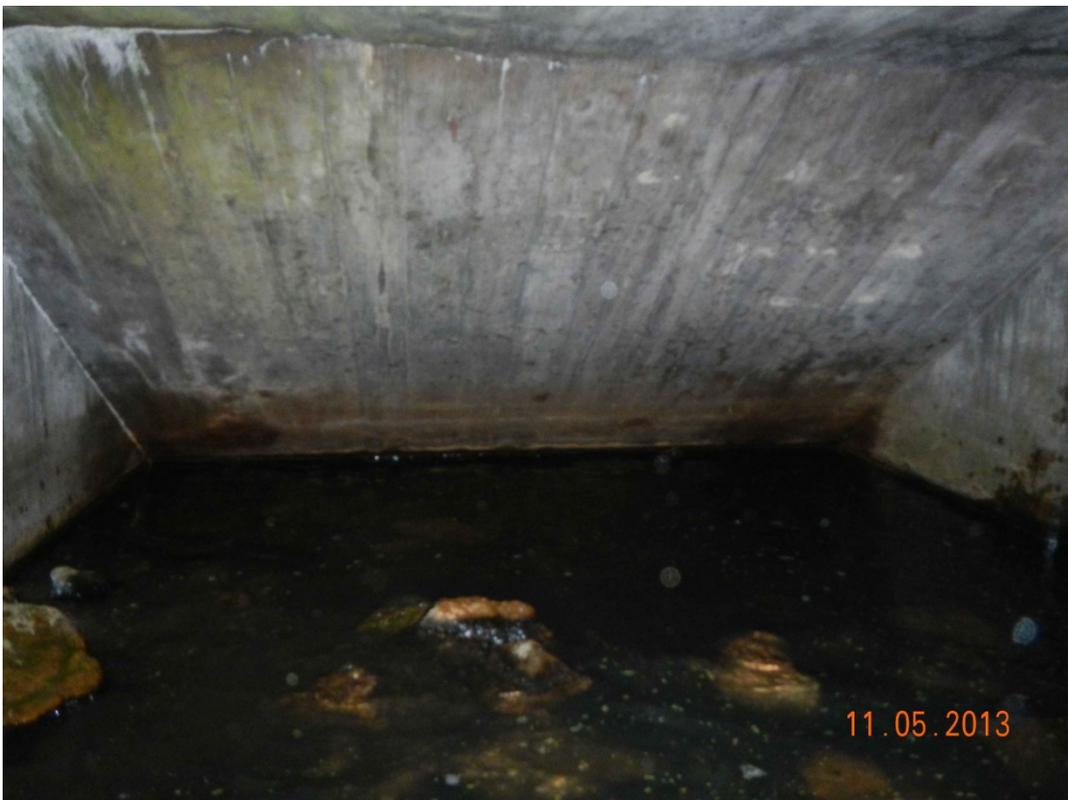
Photo 8: Bay 1 – west wall

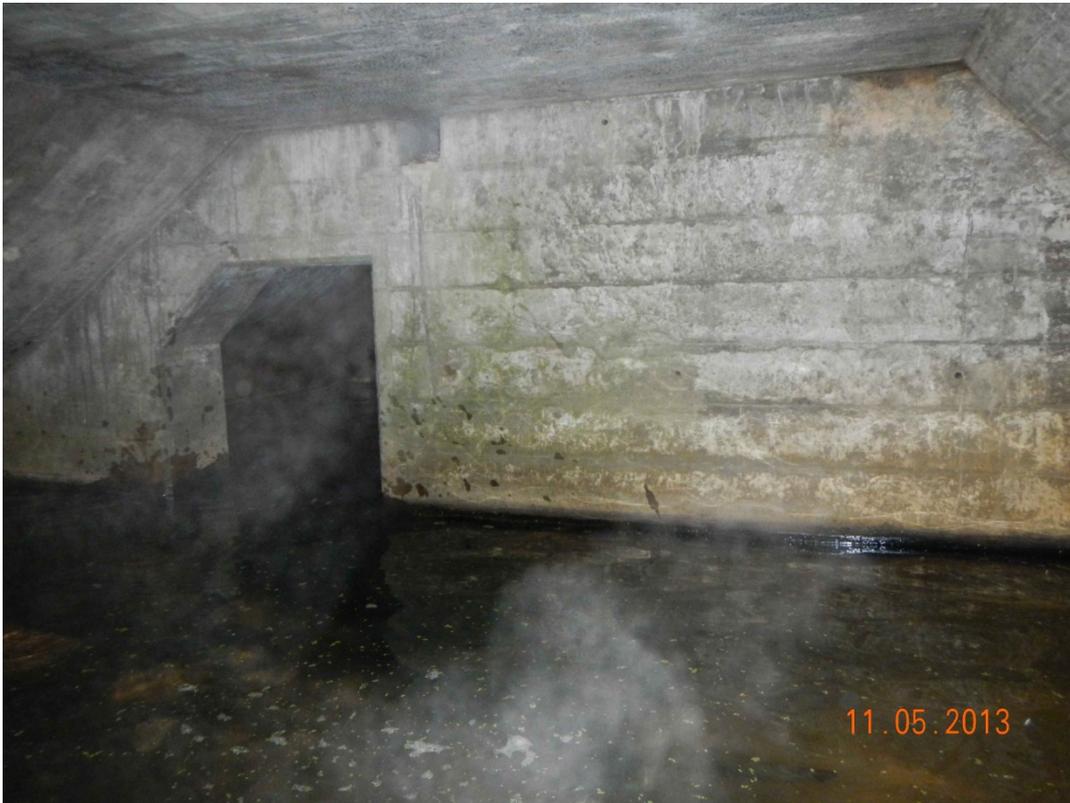
Photo 9: Bay 1 – north wall

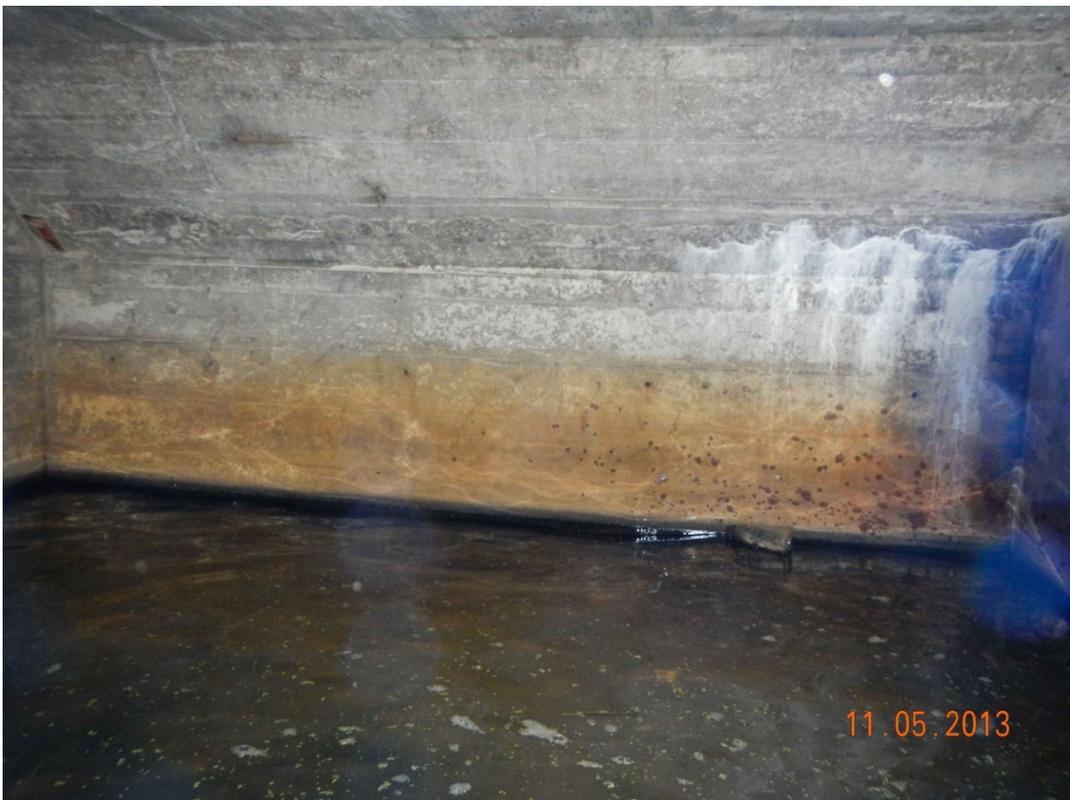
Photo 10: Bay 1 – east wall

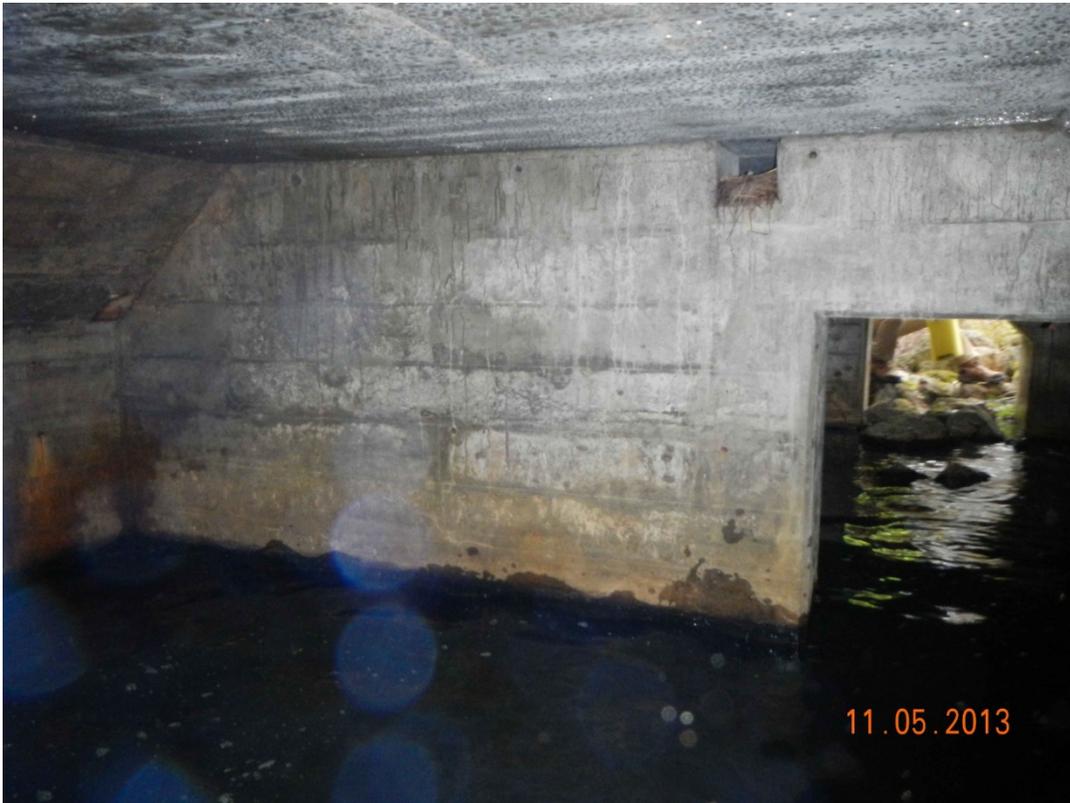
Photo 11: Bay 2 – south wall

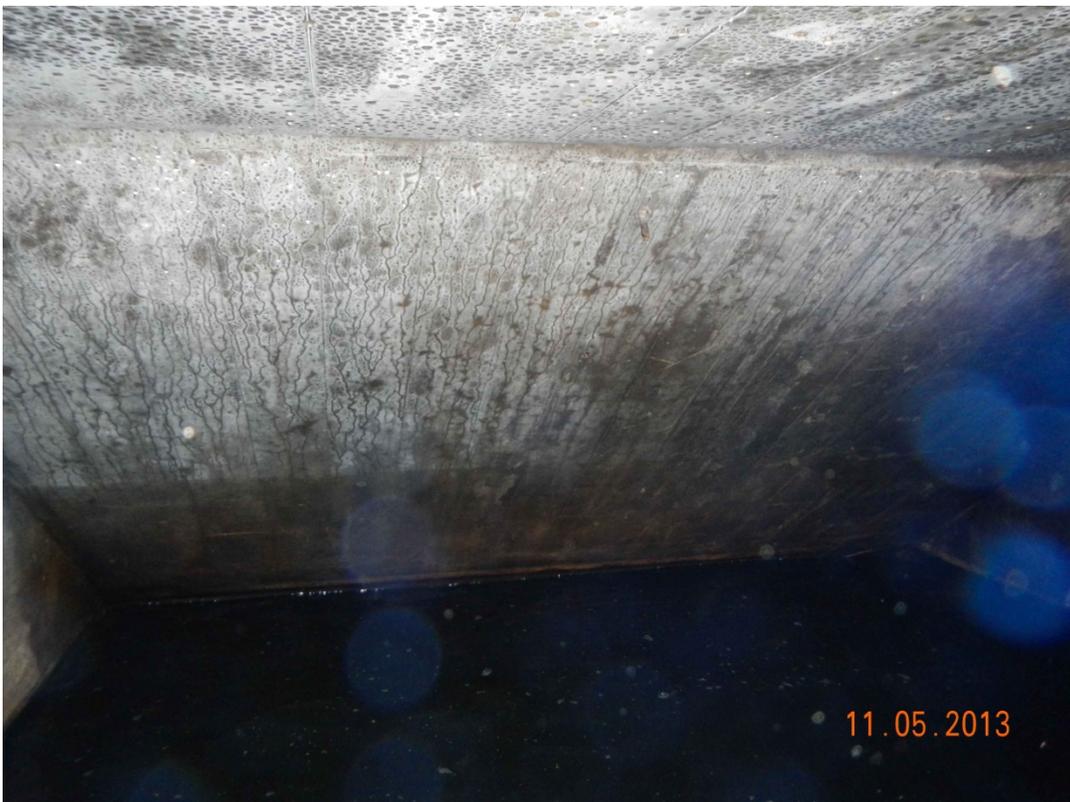
Photo 14: Bay 2 – west wall

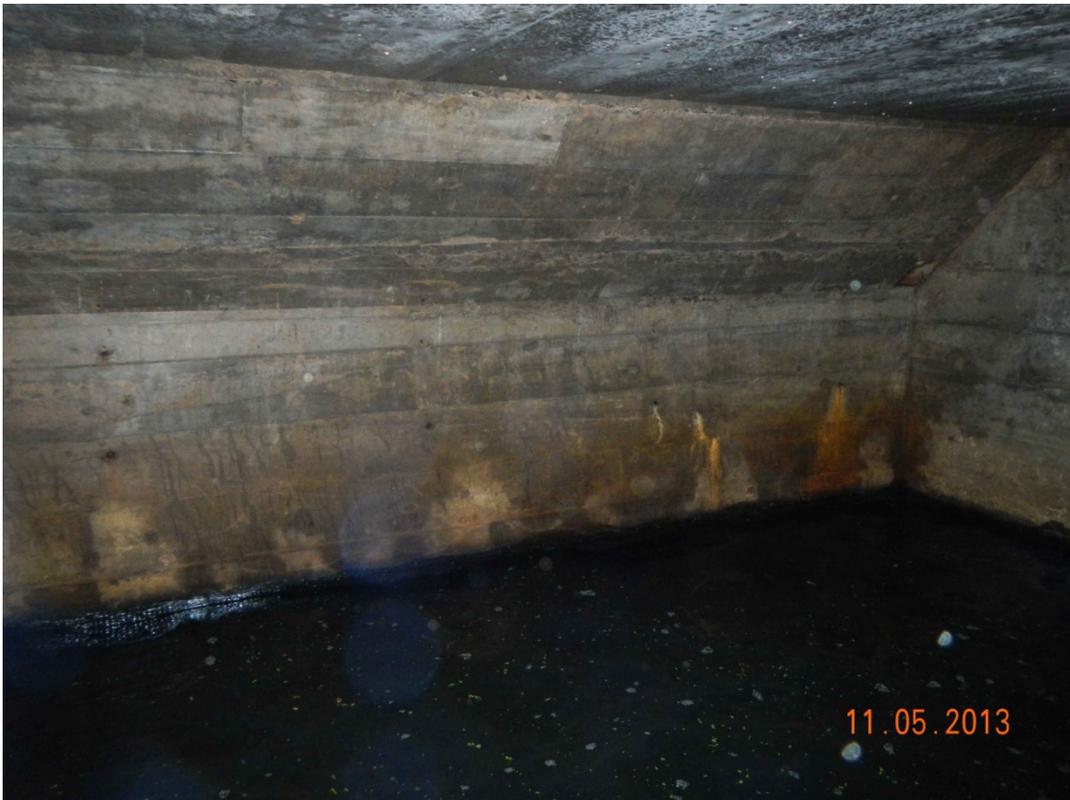
Photo 12: Bay 2 – east wall

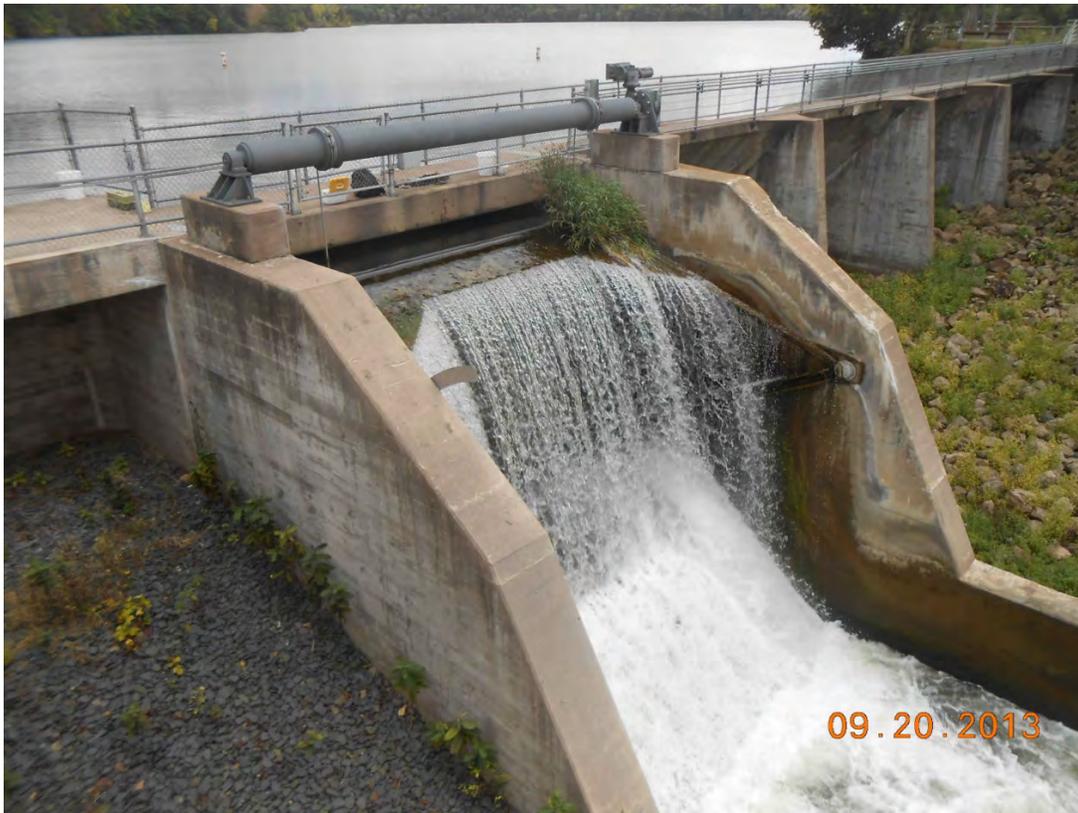
Gate 1 is in good condition as no deficiencies were observed.

Photo 1: Gate 1 – downstream side with water flowing over gate in normal operation

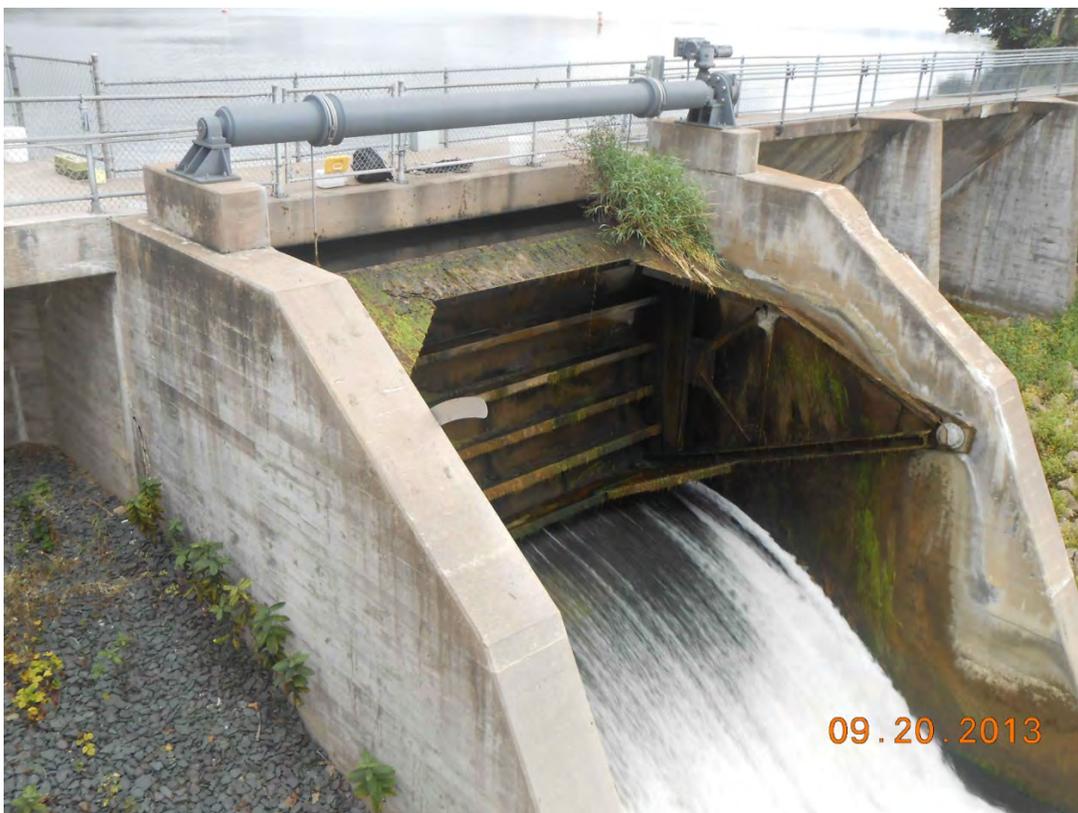
Photo 2: Gate 1 – downstream side with water flowing below gate for inspection

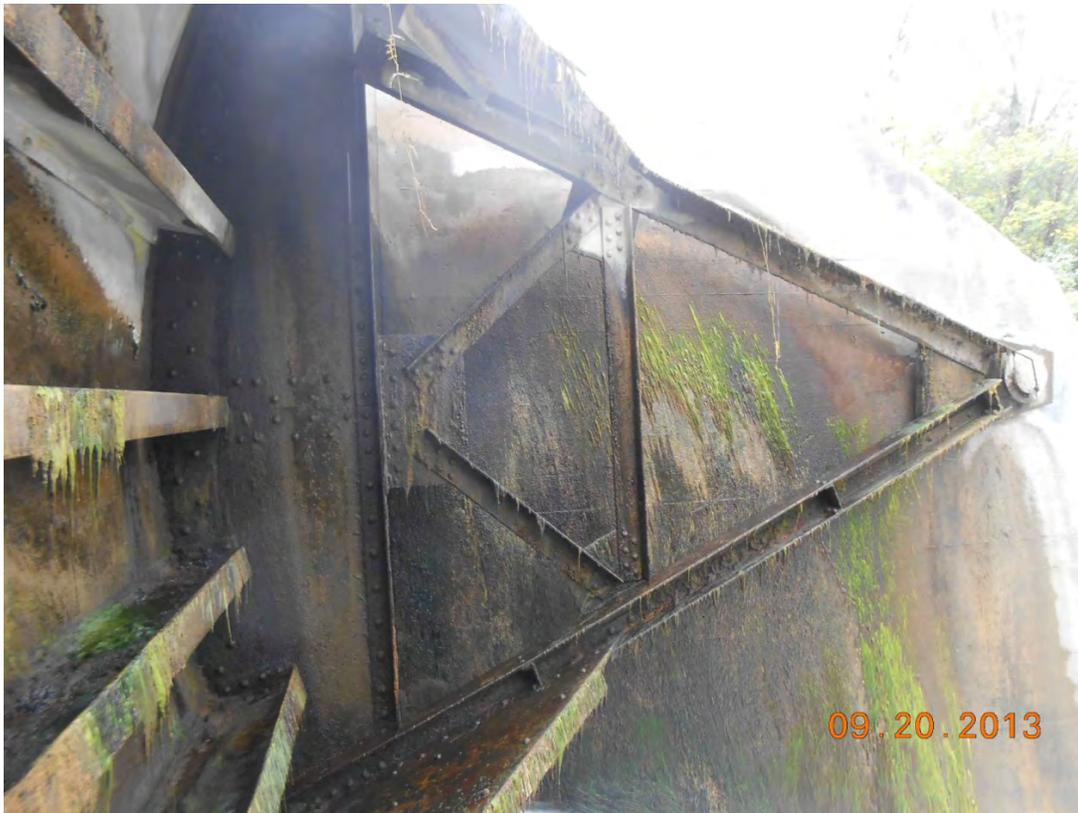
Photo 3: Gate 1 – left arm

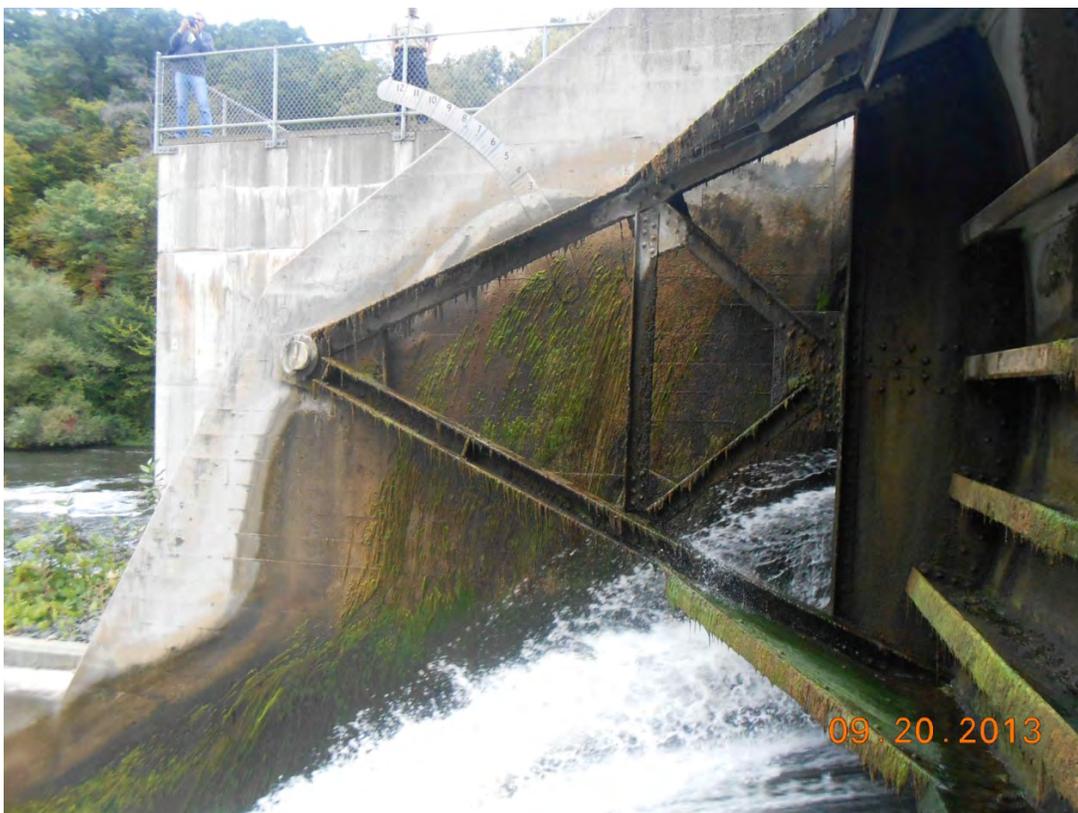
Photo 4: Gate 1 – right arm

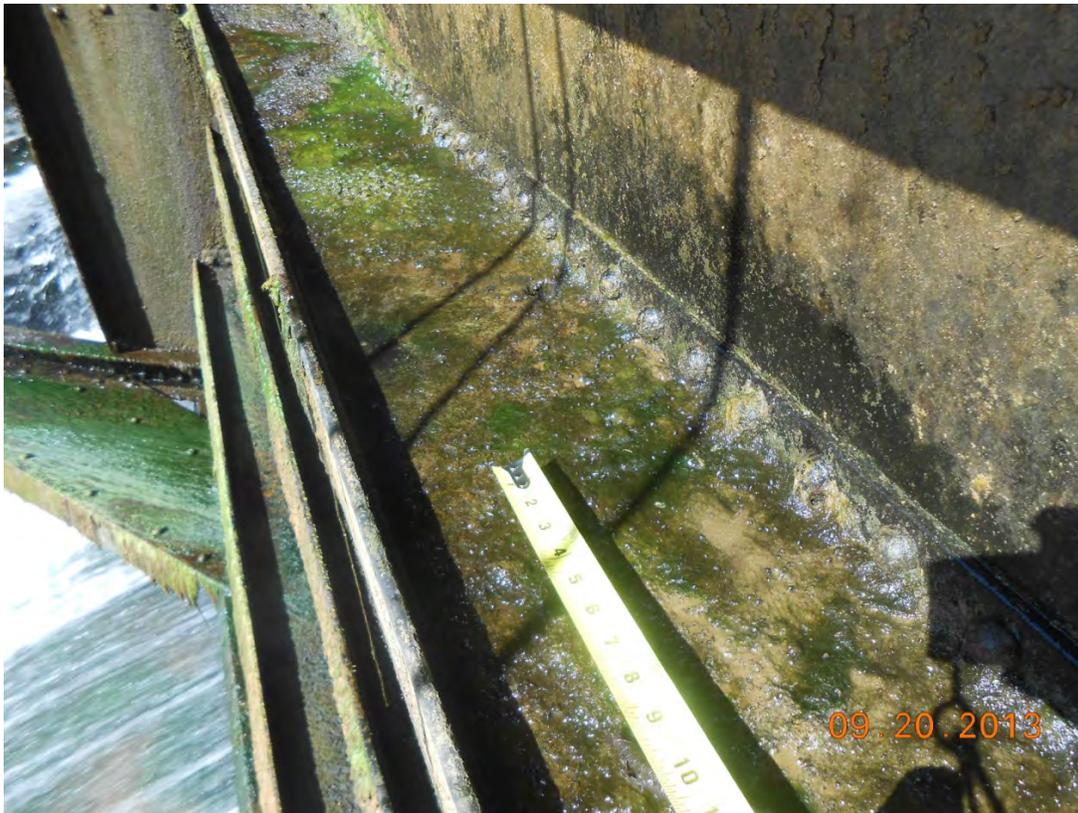
Photo 5: Gate 1 – typical marine growth

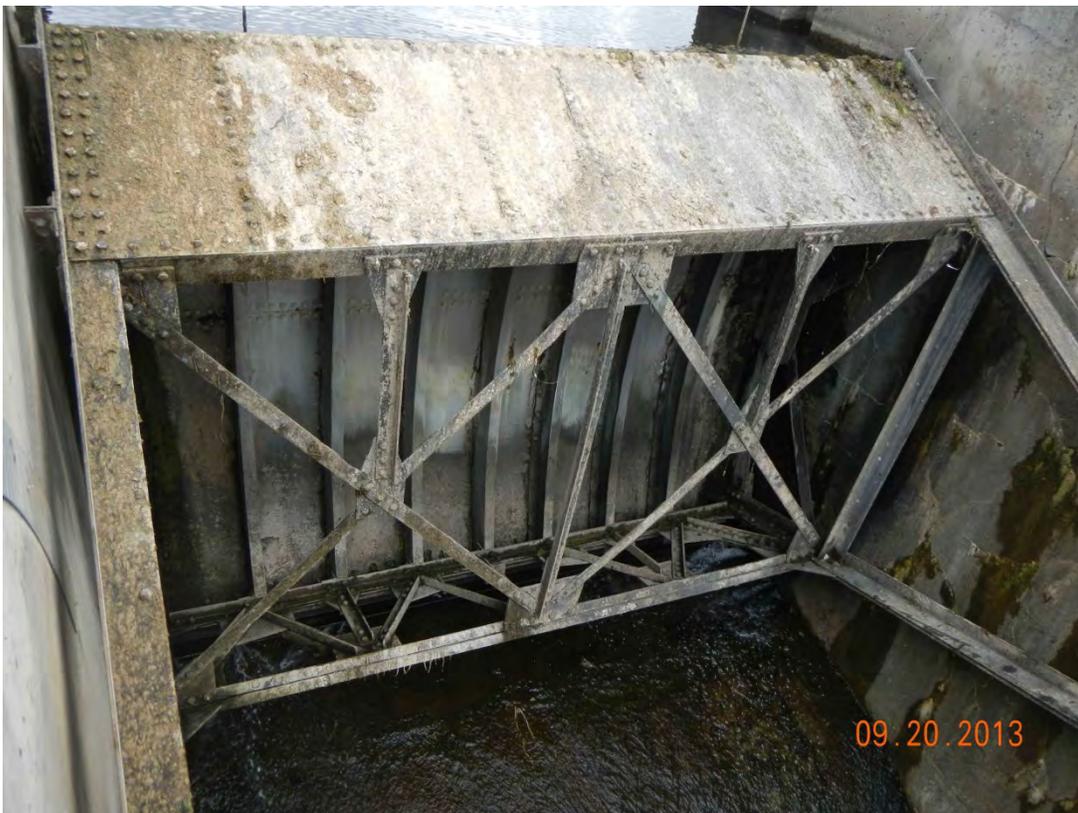
Gates 2 to 4 are in poor condition due to heavy corrosion and section loss.

Photo 6: Gate 2 – downstream side

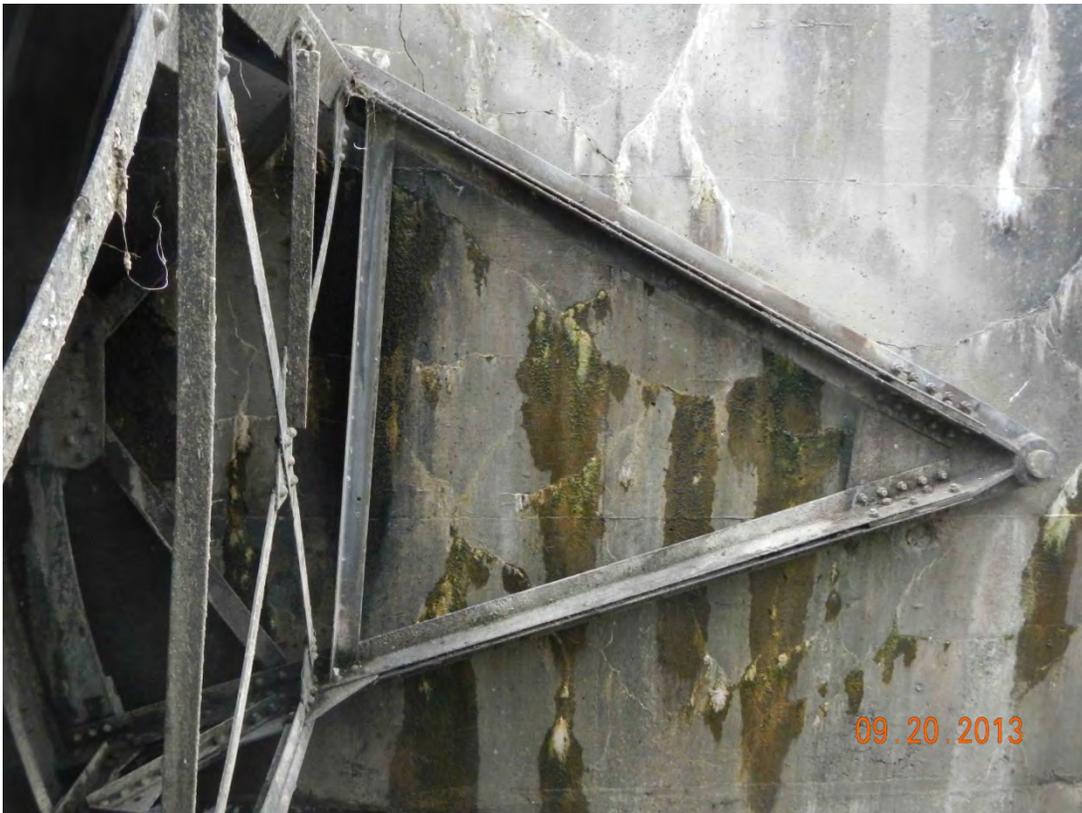
Photo 7: Gate 2 – left arm

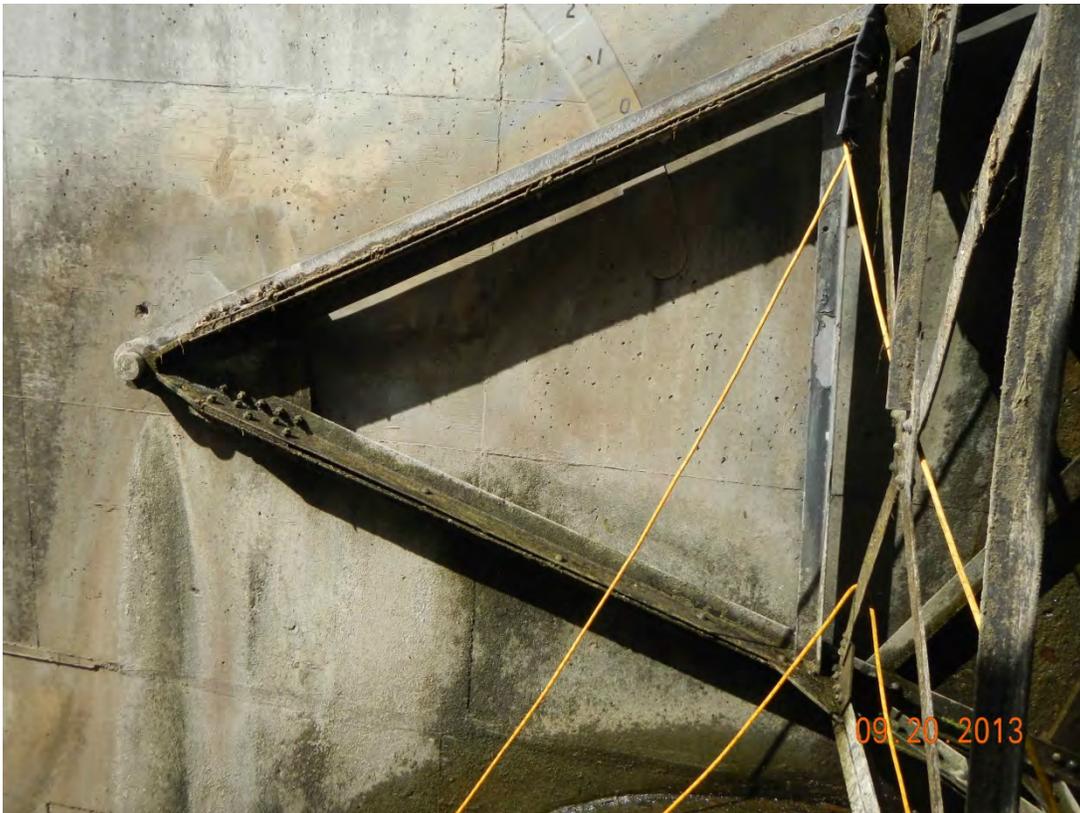
Photo 11: Gate 2 – right arm

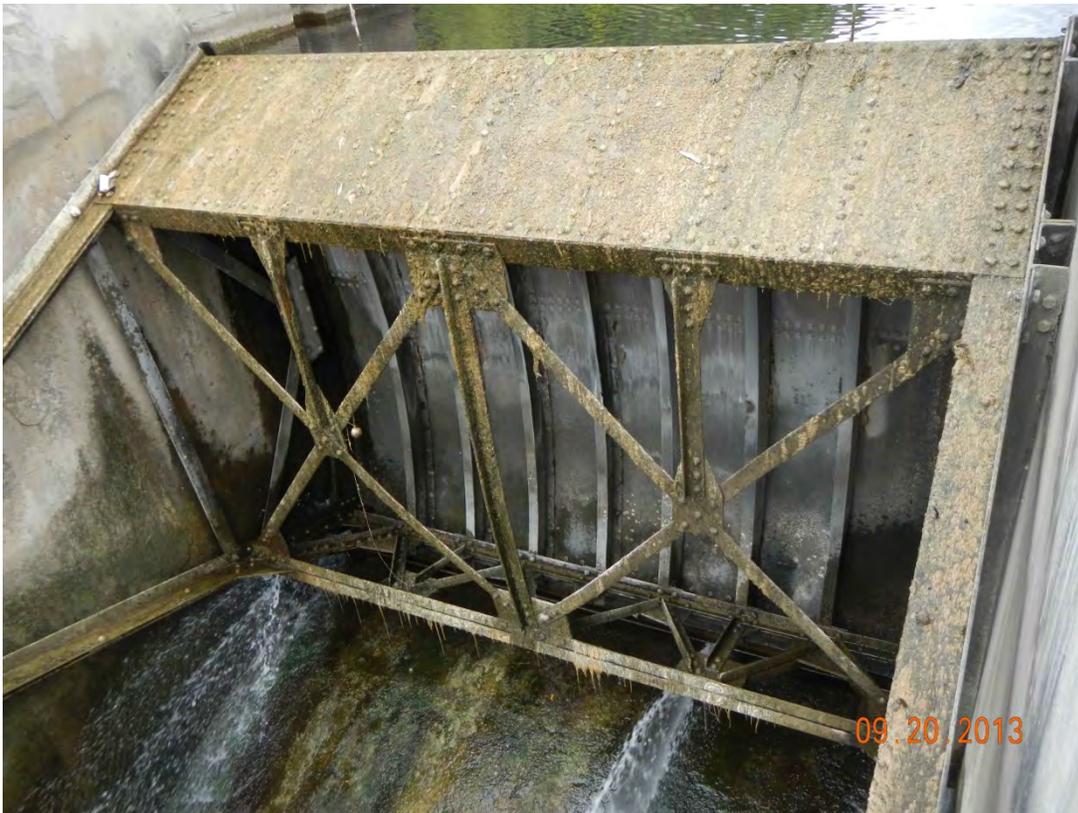
Photo 21: Gate 3 – downstream side

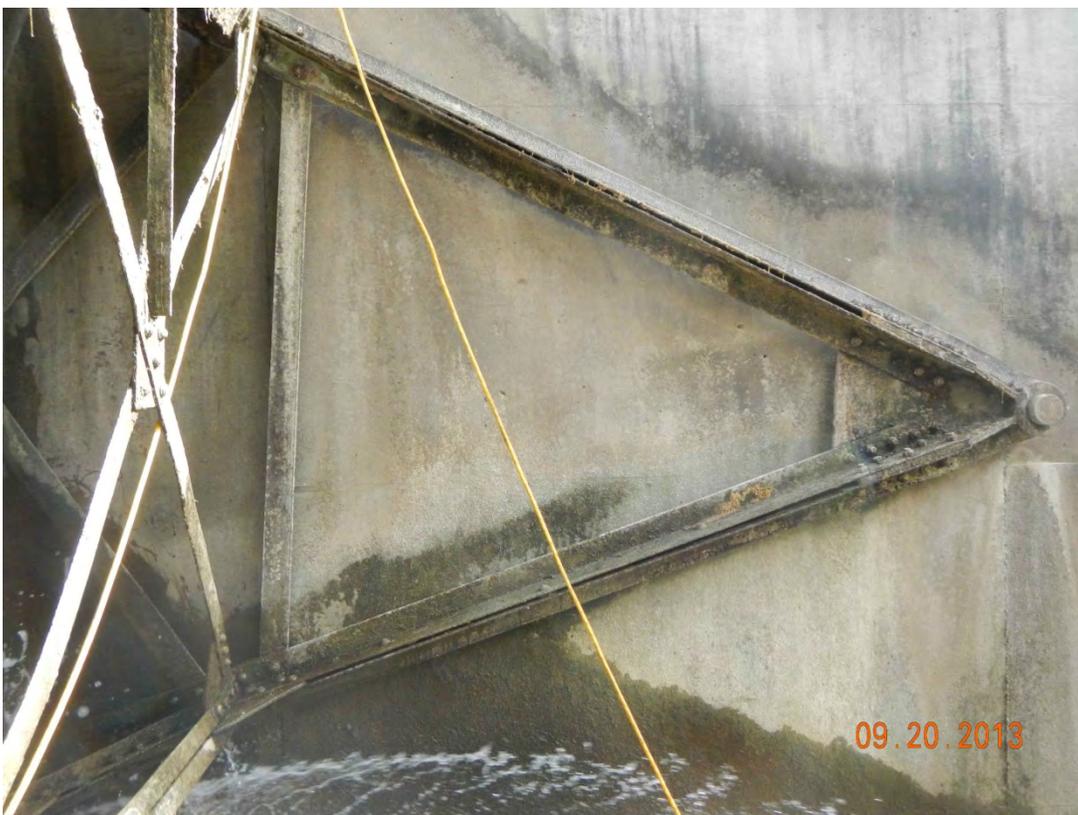
Photo 22: Gate 3 – left arm

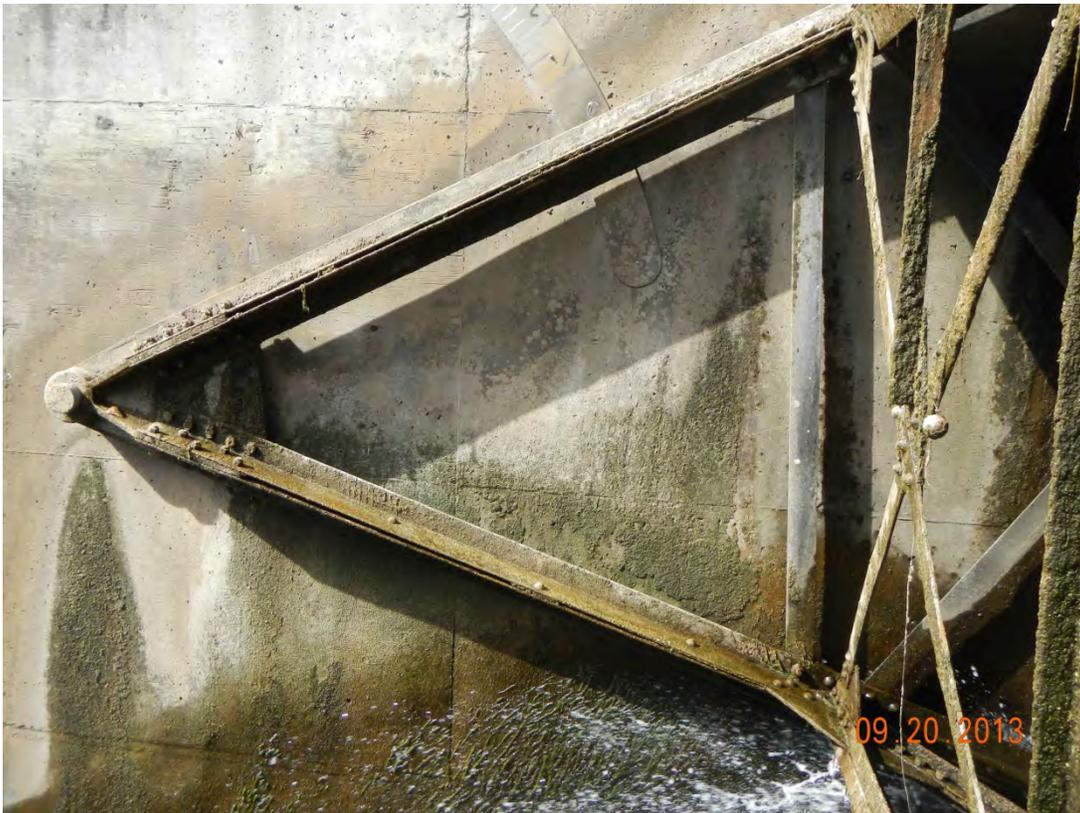
Photo 25: Gate 3 – right arm

The arm members with no clearance to the side walls should be analyzed to determine how much section can be removed to provide clearance and if any replacement section is needed.

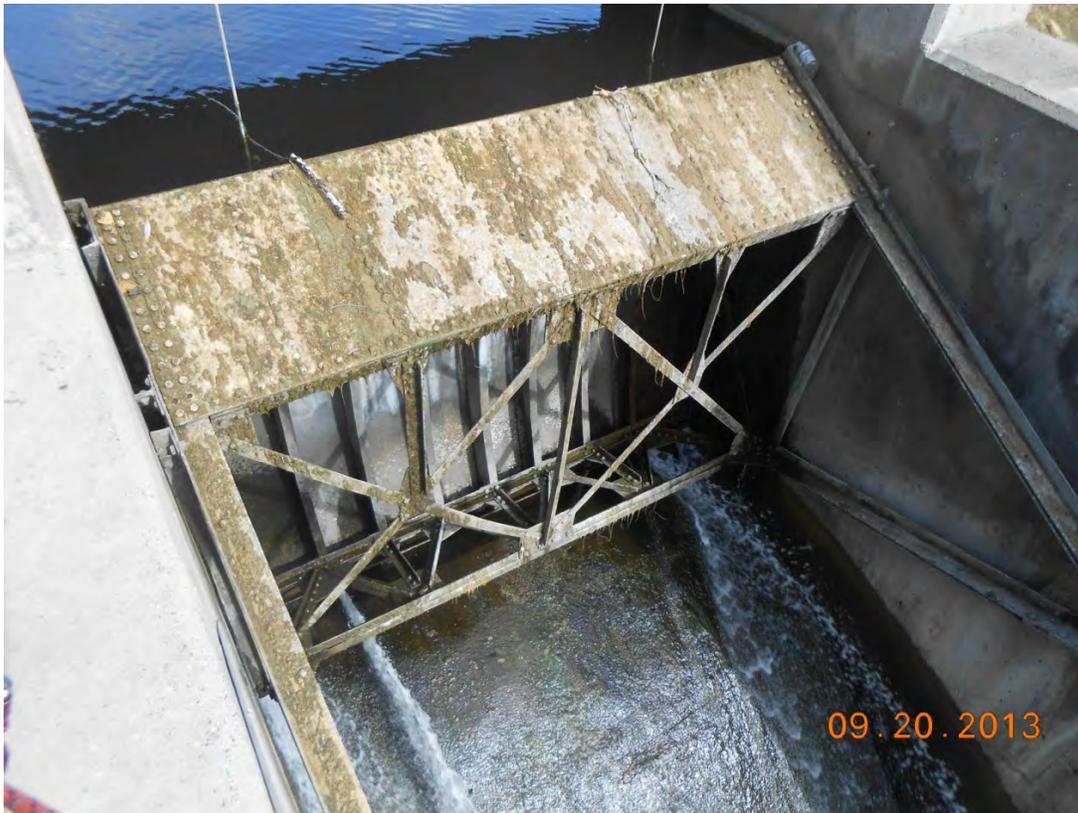
Photo 45: Gate 4 – downstream side of gate

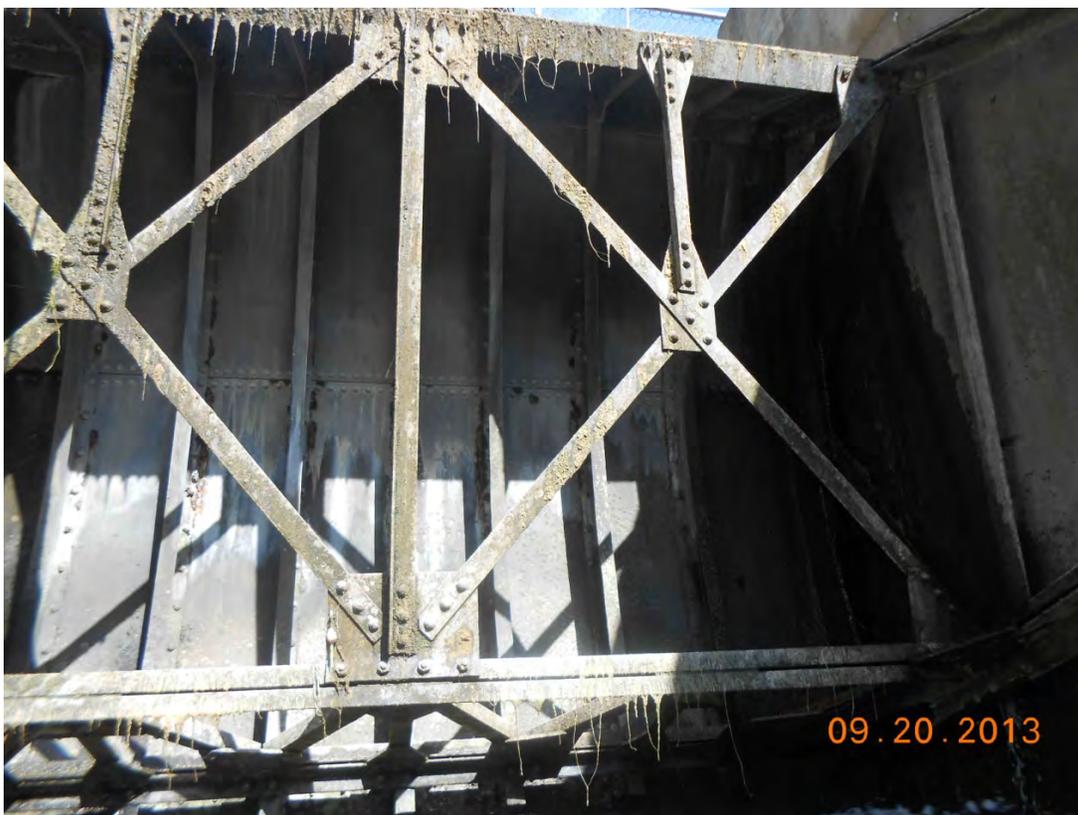
Photo 46: Gate 4 – typical framing of Gates 2 to 4

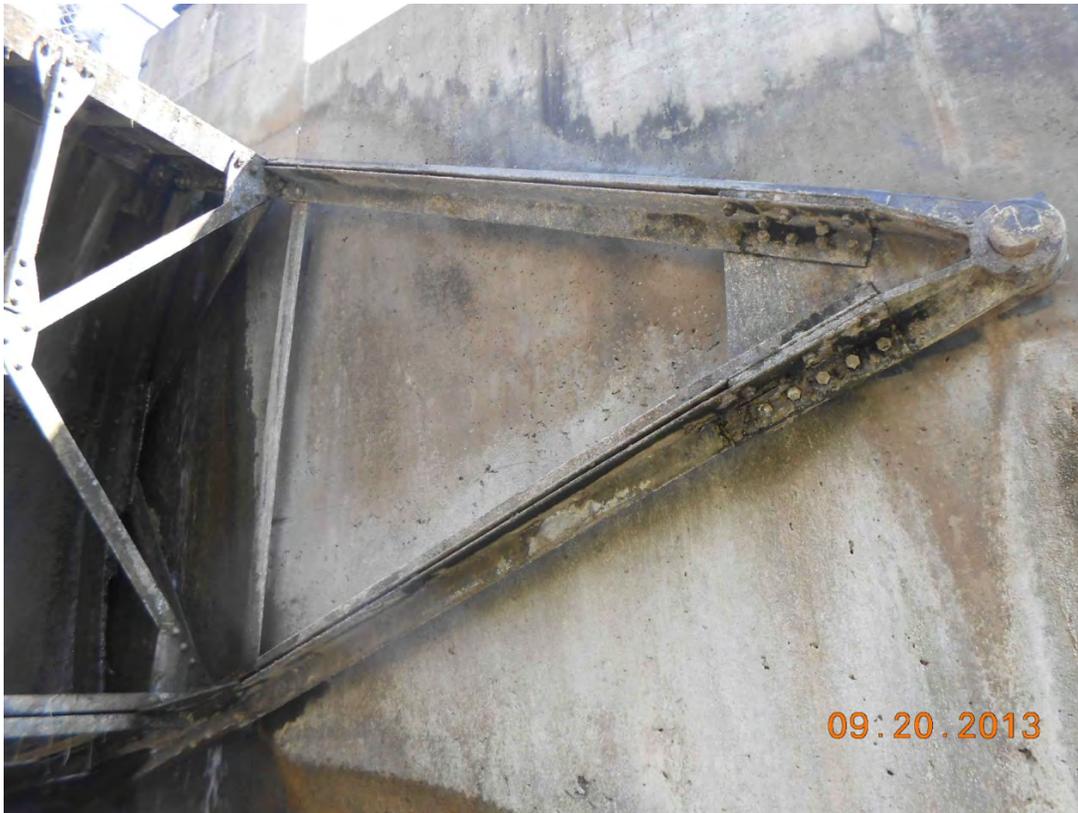
Photo 47: Gate 4 – left arm

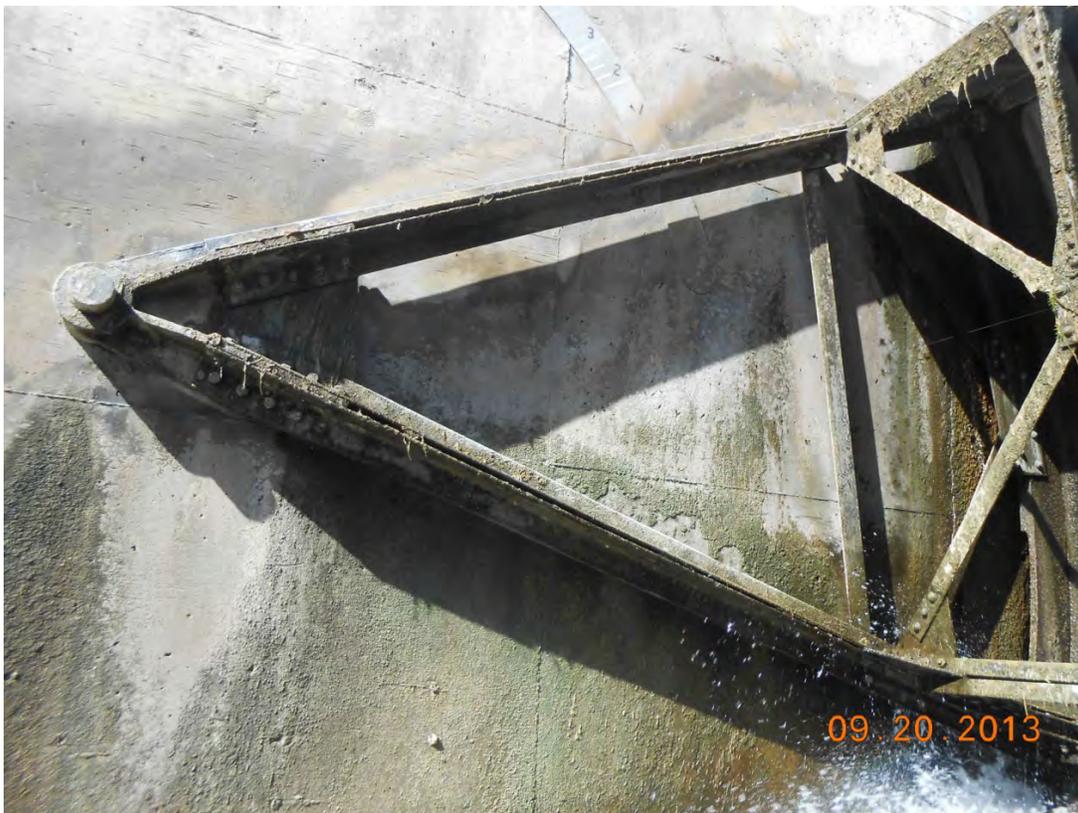
Photo 48: Gate 4 – right arm

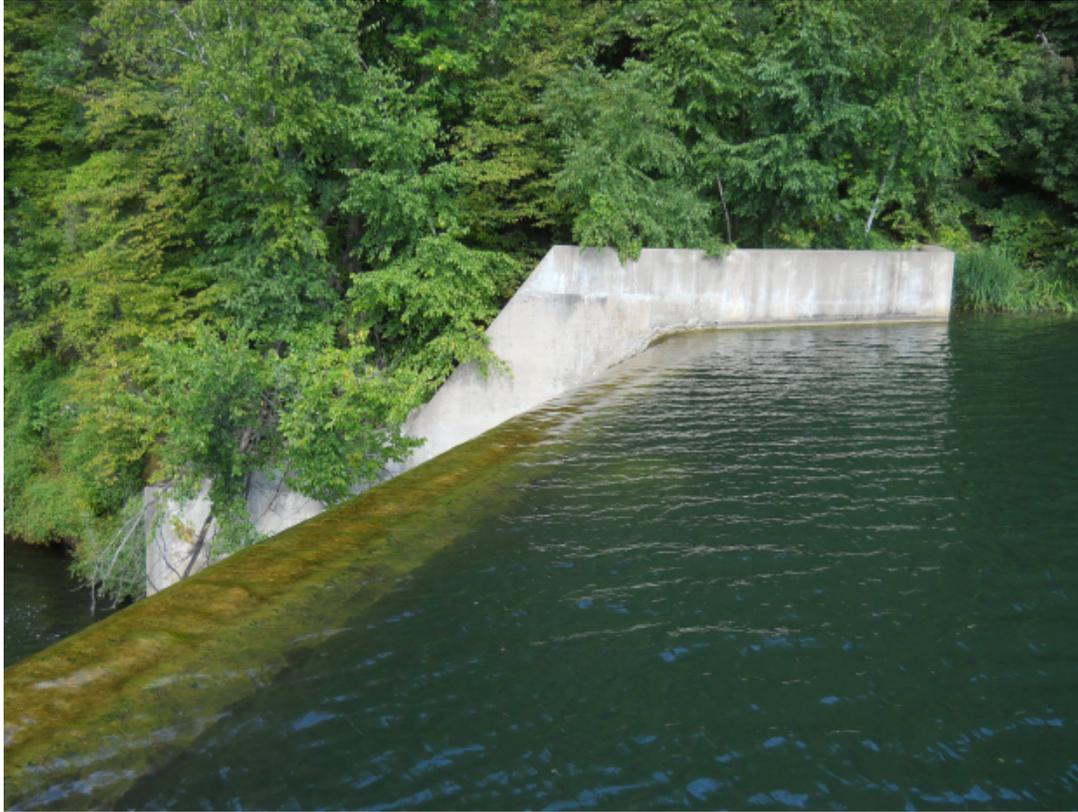
Photograph 1: Right Abutment Wall and Overflow Spillway
